Wellington Street Bicycle Infrastructure,
between Johnston Street and Queens
Parade

Road Safety Audit

Audit Stage: Existing Conditions

| Report number | S20230305-REP-001 |

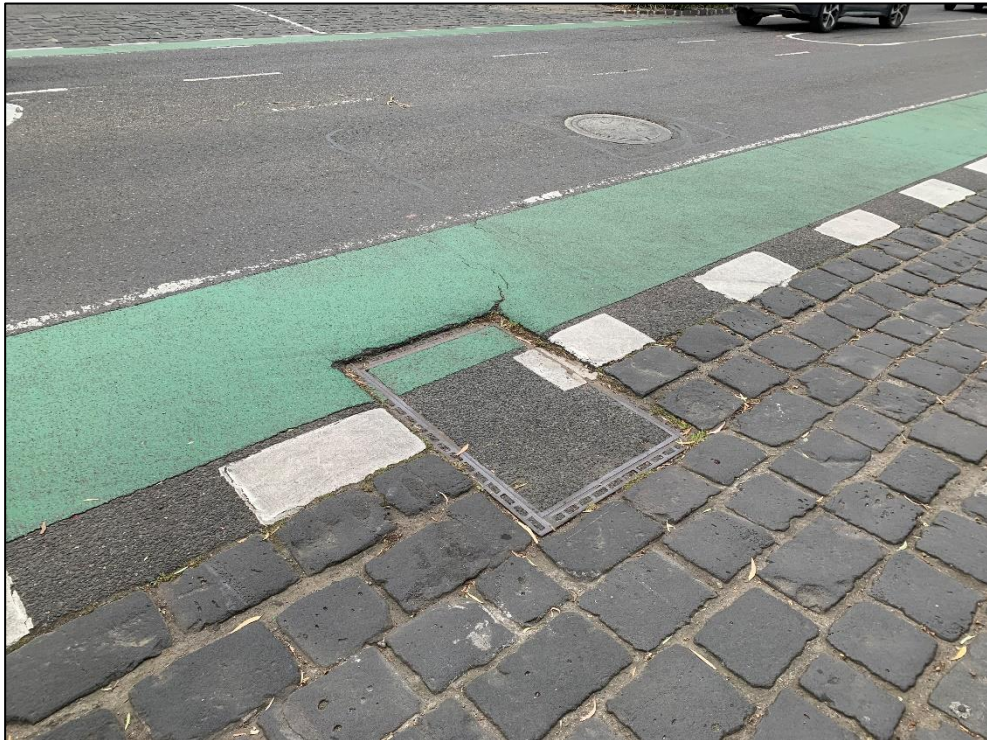
Photo 2: Depressed drain cover within the bicycle lane, at the Wellington Street and Sackville Street intersection

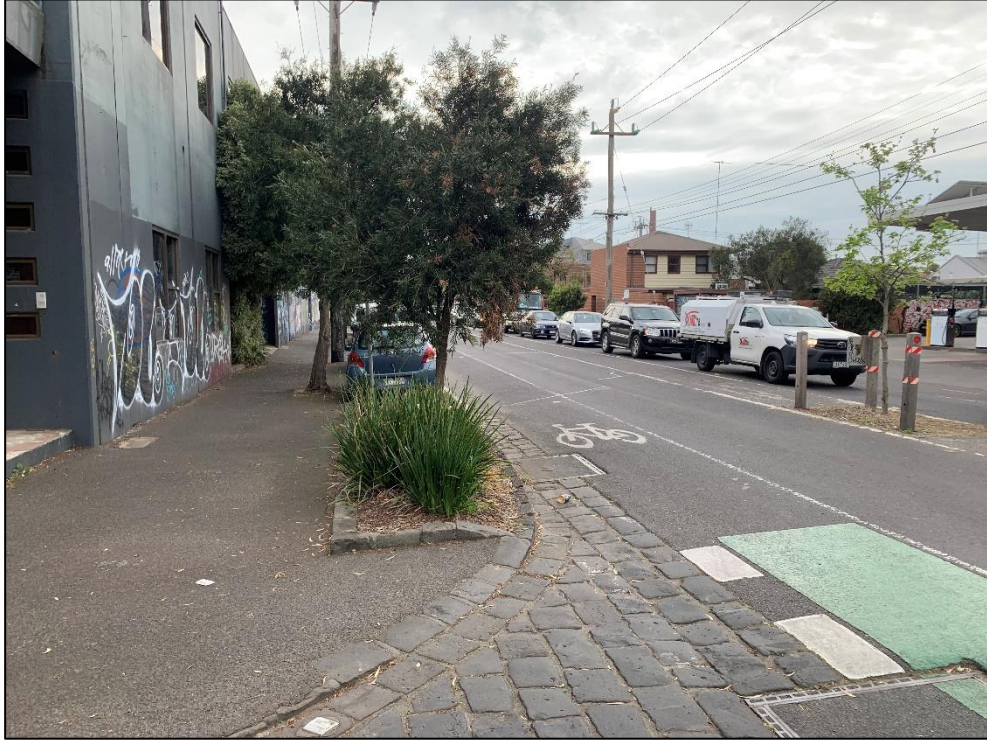
Photo 3: Typical sight distance from side roads turning onto Wellington Street, facing north. Note the vegetation and parked vehicles that provide this obstruction

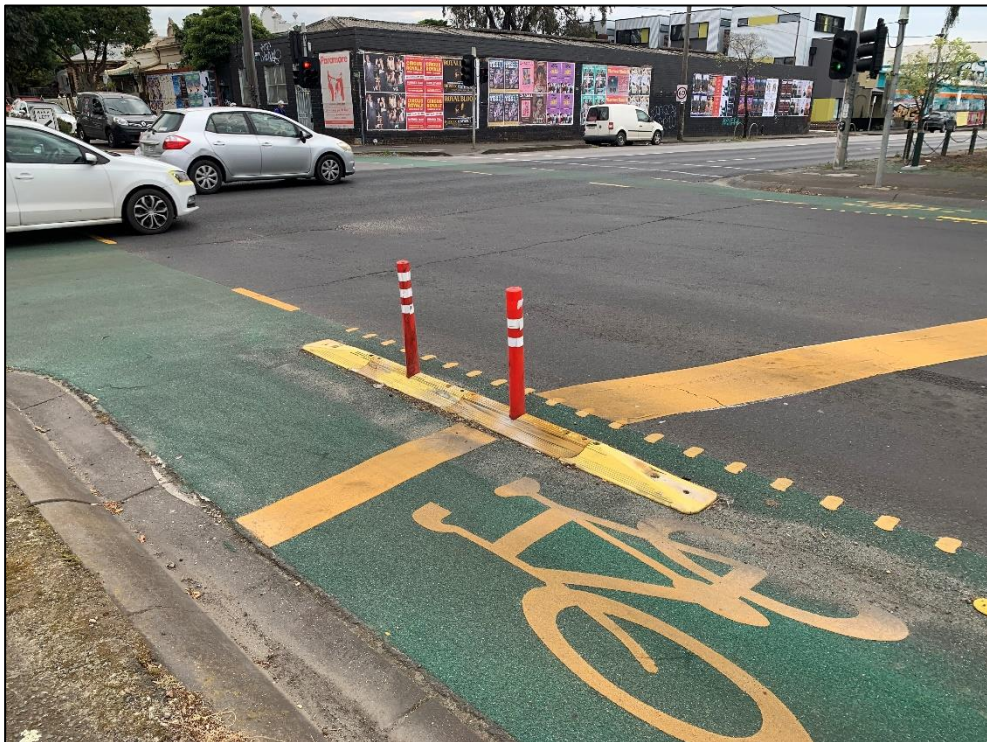
Photo 4: Temporary bicycle infrastructure at the Wellington Street and Alexandra Parade intersection

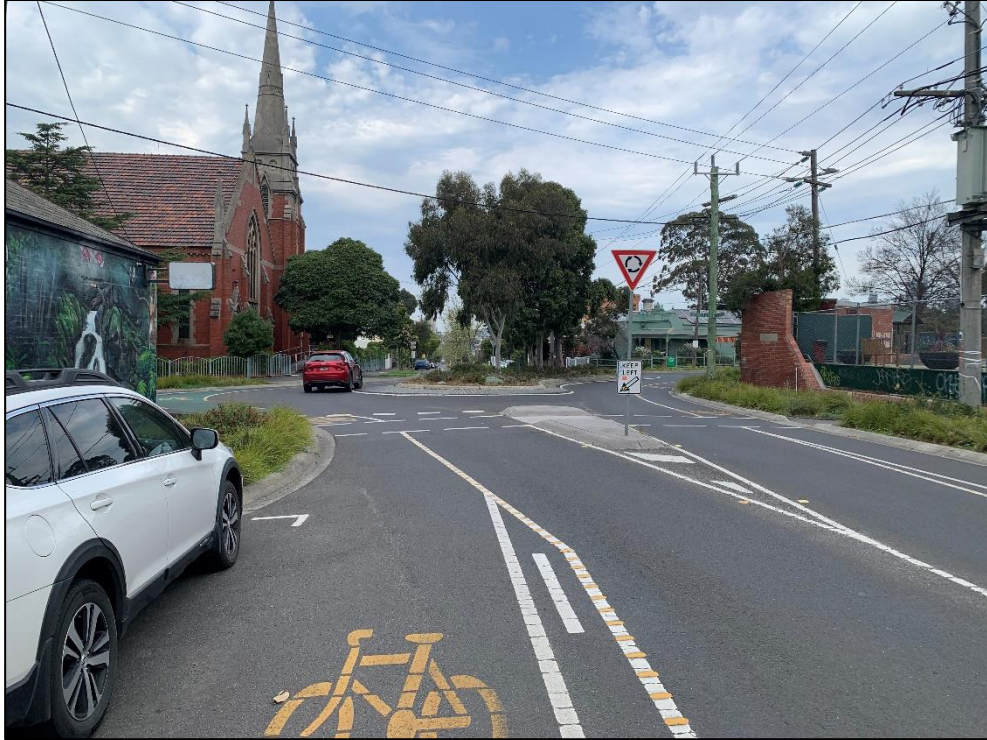
Photo 5: Northbound approach to the “peanut” roundabout at the Wellington Street and Hodgkinson Street intersection

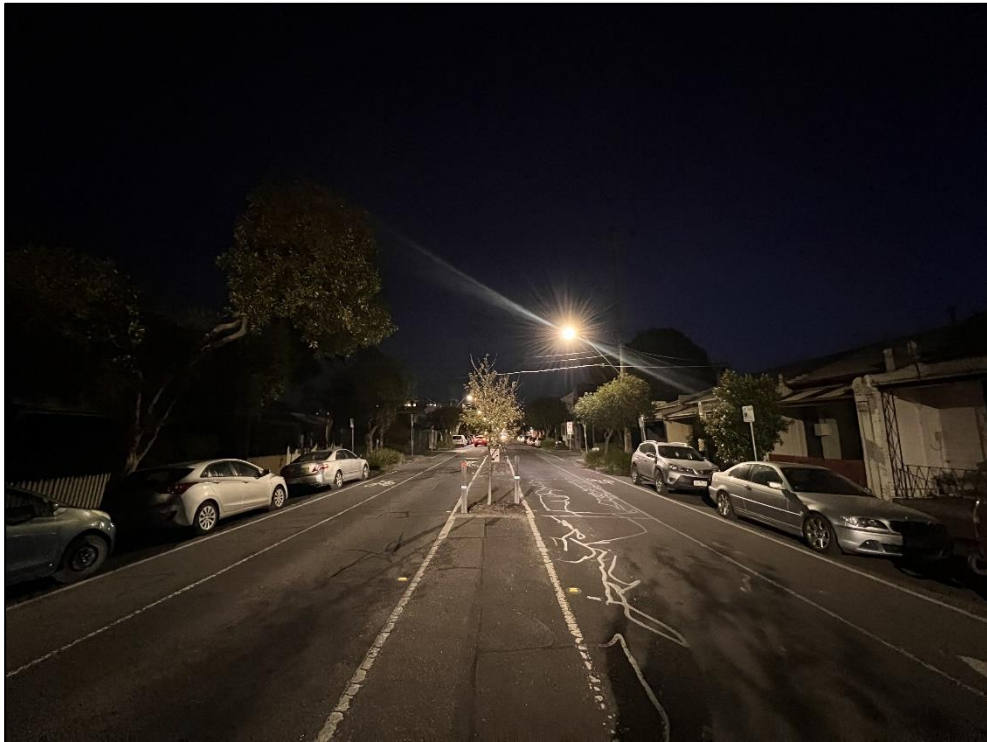
Photo 7: Typical lighting arrangement on Wellington Street, facing south (night)

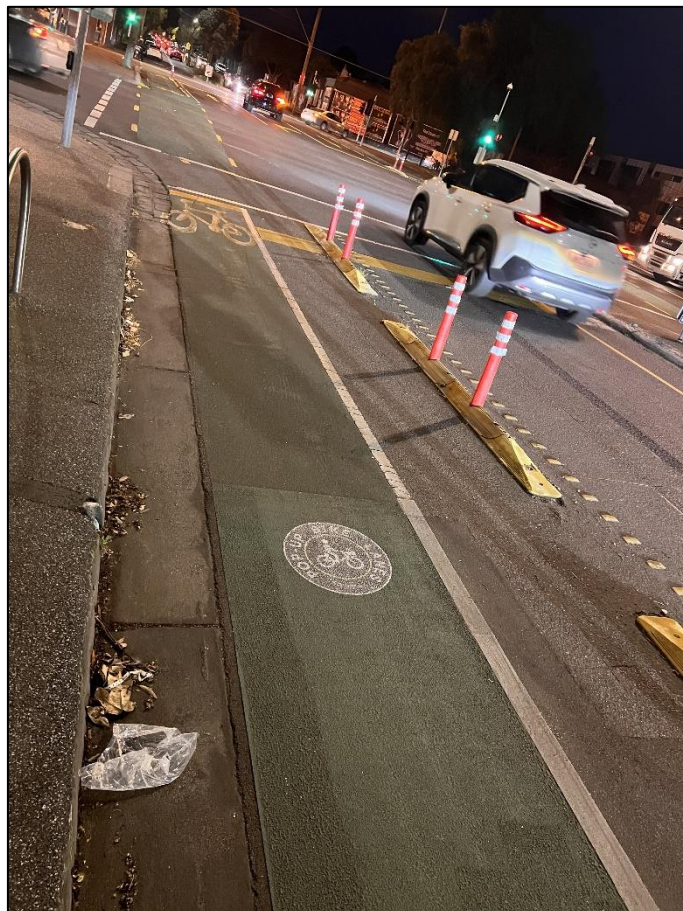
Photo 8: Temporary bicycle infrastructure on Wellington Street at its intersection with Alexandra Parade (night)

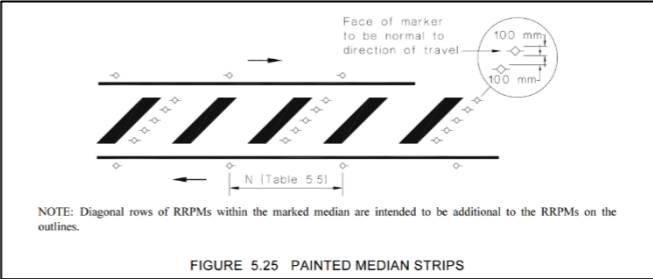
| Audit Findings | Risk Assessment | | | Recommendations | | Responsible Officer | |
|---|---|---|--|--|---|---|---|
| <p>The auditors noted recently planted trees within the median on Wellington Street between Johnston Street and Alexandra Parade. The existing median is approximately 1.5m wide. The auditors note two risks associated with this:</p> <p>1) There is a risk of uprooting of the surrounding pavement as the trees mature. This would increase the likelihood of vehicle-cyclist crashes as vehicles may attempt to dodge pavement defects and encroach into the cycle lane.</p> | Rare | Serious | MEDIUM (FSI) Safe System energy exceeds tolerable levels | Consider removing the trees and replacing the median with a narrow-painted median, per AS1742.2. Given the operating speed the risk for high severity head-on crashes can be expected to be low. (S) | | | |

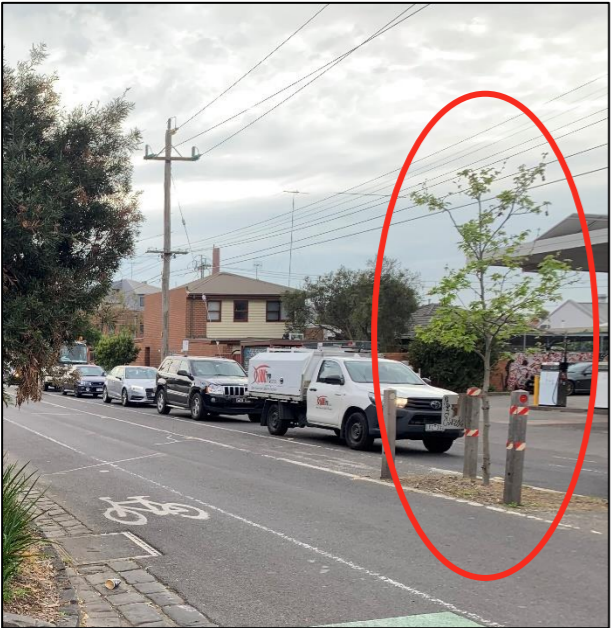
| Audit Findings | Risk Assessment | | | Recommendations | | Responsible Officer | |
|---|---|---|--|--|---|---|---|
| <p>2) The trees at this location are not protected by a kerb further increasing the risk for run-off-road crashes. Given the operating speed on Wellington Street impact speeds are likely to be below the Safe System tolerance for this crash type (50km/h).</p> | Unlikely | Moderate | MEDIUM Safe System energy within tolerable levels | Consider reducing the speed limit to reduce the risk of errant motorists striking the trees. (S) The auditors note the recommended speed reduction will improve the level of safety for all vulnerable road users within the area. | | | |

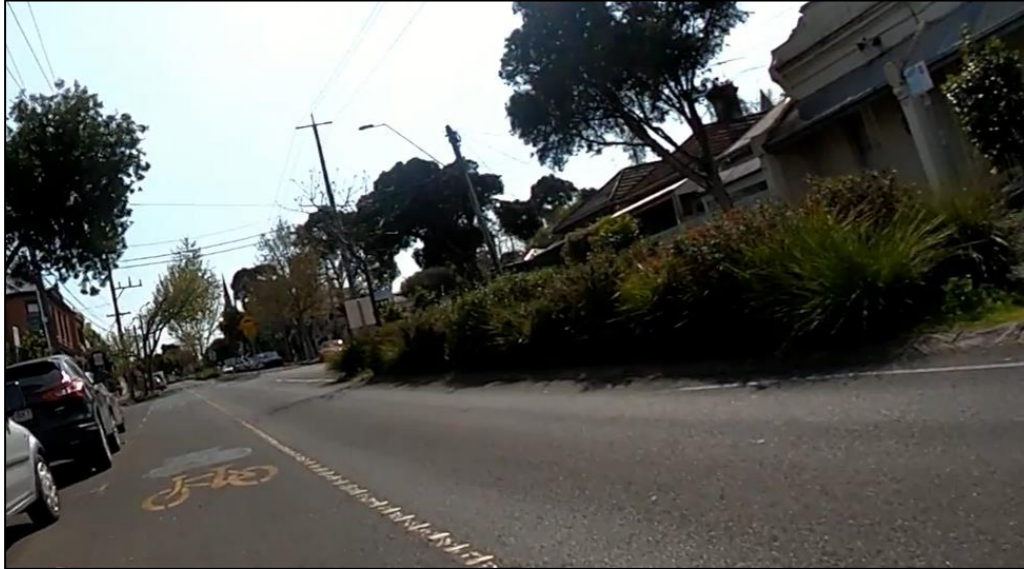
| Audit Findings | Risk Assessment | | | Recommendations | | Responsible Officer | |
|---|---|---|--|---|---|---|---|
| <p>Auditors noted significant vegetation overgrowth along the kerbed medians. The auditors note two risks associated with this:</p> <p>3) This obstructs the ability for vehicles to clearly identify the edge line and increases the risk of vehicles striking or mounting the median (increasing the risk of run-off-road crashes).</p> | Unlikely | Minor | LOW Safe System energy within tolerable levels | | Consider conducting landscaping maintenance to reinstate kerb visibility. (S) | | |

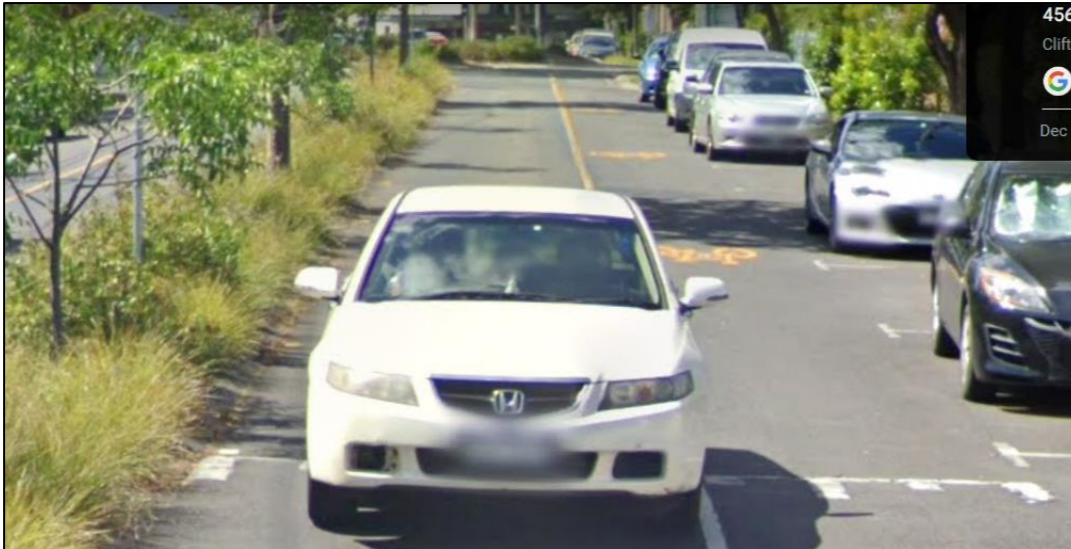
| Audit Findings | Risk Assessment | | | Recommendations | | Responsible Officer | |
|---|---|---|--|---|---|---|---|
| <p>4) Additionally, this may also lead to vehicles driving closer to the cycle lane to avoid the potential of striking the median. This increases the likelihood of vehicle-cyclist crashes as a result of vehicles encroaching into the cycle lane.</p> | Rare | Serious | MEDIUM (FSI) Safe System energy exceeds tolerable levels | | Consider conducting landscaping maintenance to reinstate kerb visibility. (S) | | |

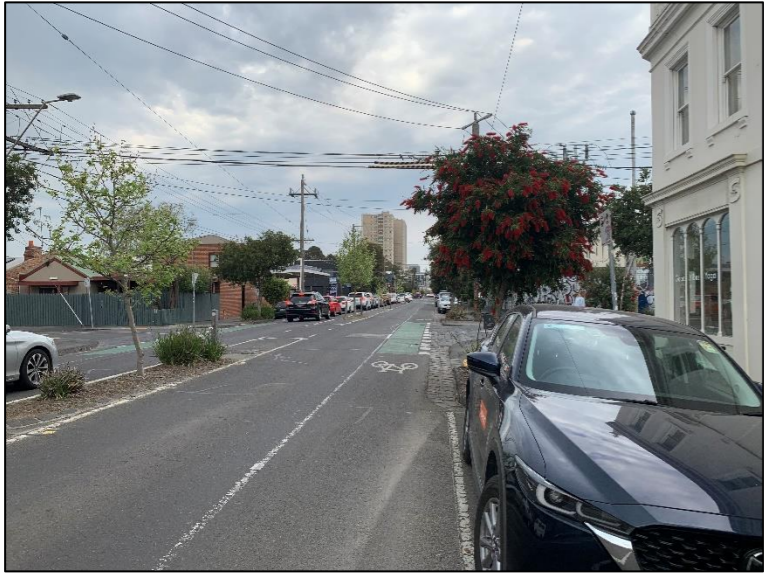
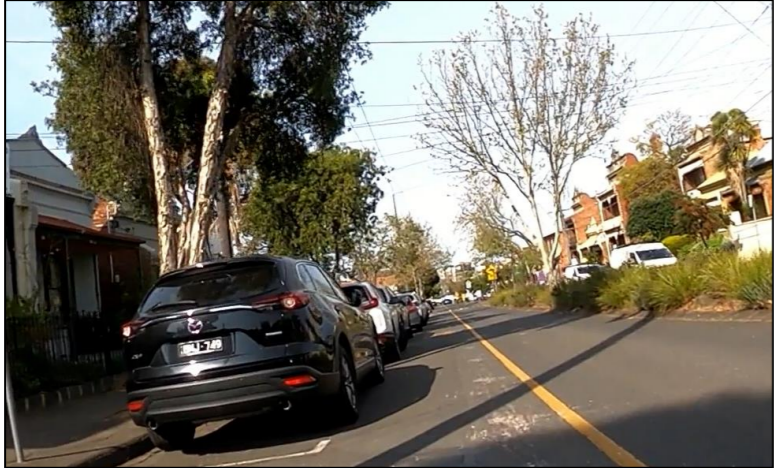
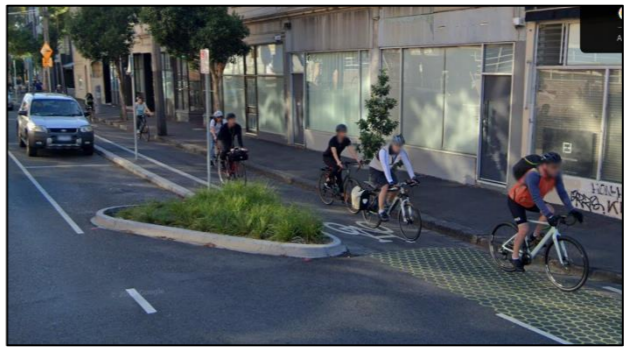
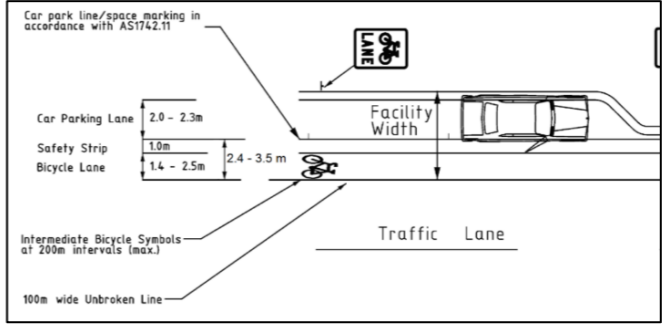
| Audit Findings | Risk Assessment | | | Recommendations | | Responsible Officer | |
|---|---|---|---|--|---|---|---|
| <p>5) The bicycle lanes on Wellington Street run adjacent to parallel-parked vehicles along the length of the audit site. Auditors are concerned of the dooring risk present. This could result in a cyclist colliding with a door or an oncoming vehicle in the adjacent lane. This risk increases during peak hours and night-time where there are greater volumes of vehicles and cyclists on the road, visibility is poor, and greater parking turnover.</p> <p>Additionally, auditors also noted parked vehicles encroaching into adjacent cycle lane at several locations. This encroachment encourages cyclists to travel closer to the adjacent traffic lane and further increases the likelihood of a dooring accident as the available space to overtake an open vehicle door is decreased and sightlines for approaching cyclists is reduced.</p> | Unlikely | Serious | <p>HIGH</p> <p>(FSI)</p> <p>Safe System energy exceeds tolerable levels</p> | <p>Consider continuing the configuration (protected bicycle lane) south of Johnston Street north to Queens Parade. Relocating cycle lanes between kerb and parking with a buffer between vehicles and the cycle lane reduces the risk of dooring or cyclist falling into oncoming traffic due to dooring. (P)</p> <p>Consider physical barrier between cycle and parking lanes such as a non-mountable kerb or Klemmfix barriers to assure buffer space is maintained by parked vehicles. (P)</p> <p>Consider narrowing the median to provide greater space on the roadway for a “safety strip” between the parallel-parking bays and cycling lane to minimise dooring risk, per <i>Cycling Aspects of Austroads Guides and ARGRD part 3</i>. Refer to Finding 1 and 2 for further reasoning for a narrow median. (S)</p> | | | |

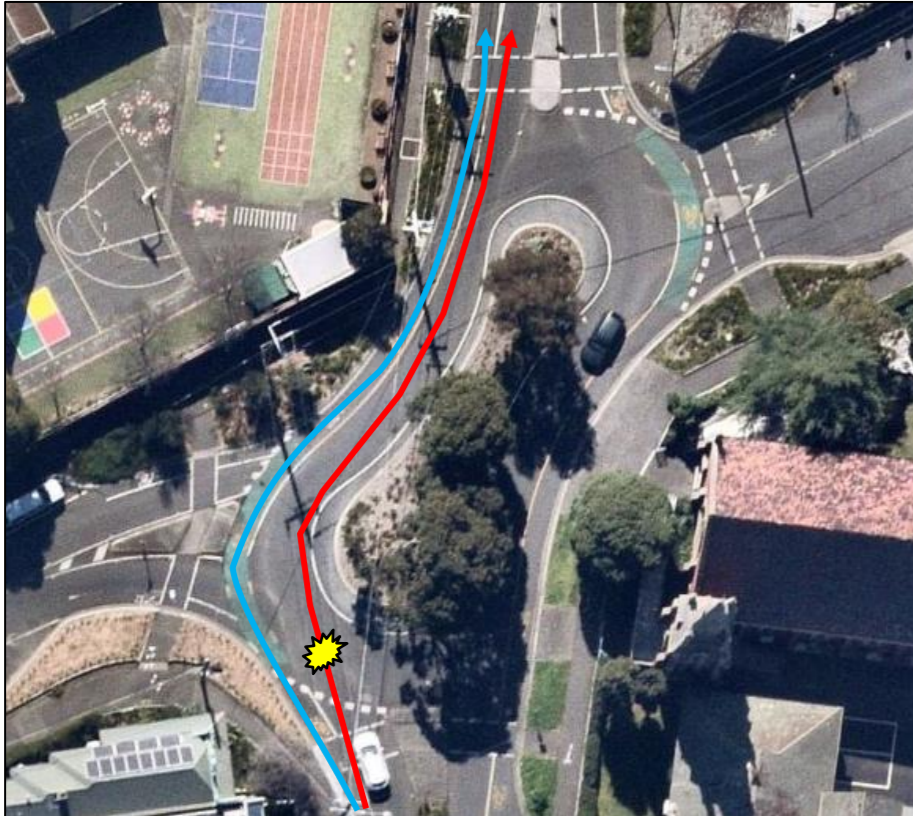
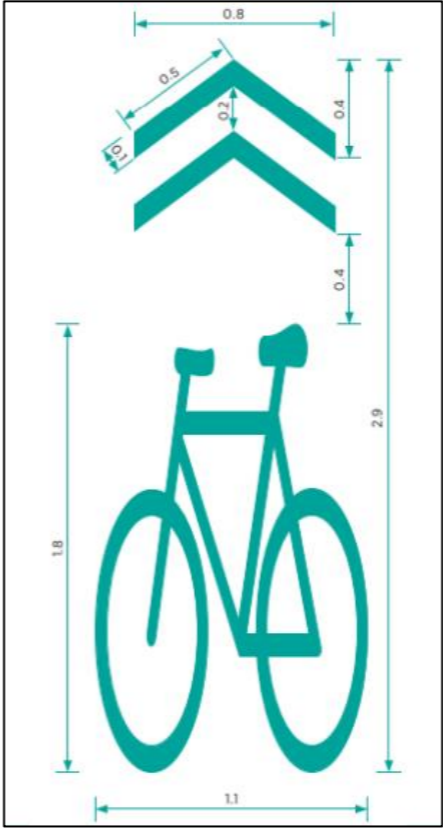
| Audit Findings | Risk Assessment | | | Recommendations | | Responsible Officer | |
|--|---|---|---|--|---|---|---|
| <p>6) There is a “peanut” roundabout at the Wellington Street and Hodgkinson Street intersection, that has a bicycle lane around its outer perimeter. Auditors are concerned that the unusual shape of the roundabout creates a circuitous route for cyclists (blue line), who will instead ride in the middle of the traffic lane (red line). This increases the likelihood of cyclist-vehicle crash types as vehicles may expect cyclists to stay within the painted bicycle lane. Given the shape of the roundabout, it is expected that crashes would occur at speeds greater than the Safe System tolerance for this crash type (30km/h).</p> | Unlikely | Serious | <p>HIGH</p> <p>(FSI)</p> <p>Safe System energy exceeds tolerable levels</p> | <p>Consider removing the bicycle lane around the roundabout and installing “sharrows” to indicate a shared environment for bicycles and motor vehicles, per <i>VicRoads Supplement to AS1742.2</i>. (S)</p> | | | |

| Audit Findings | Risk Assessment | | | Recommendations | | Responsible Officer | |
|--|---|---|---|--|---|---|---|
| | | | | <p>Consider installing LATM treatments – such as a speed cushions – on approach to the roundabout to further lower vehicle speeds, per <i>AGRD Part 8</i>. (P)</p> | | | |

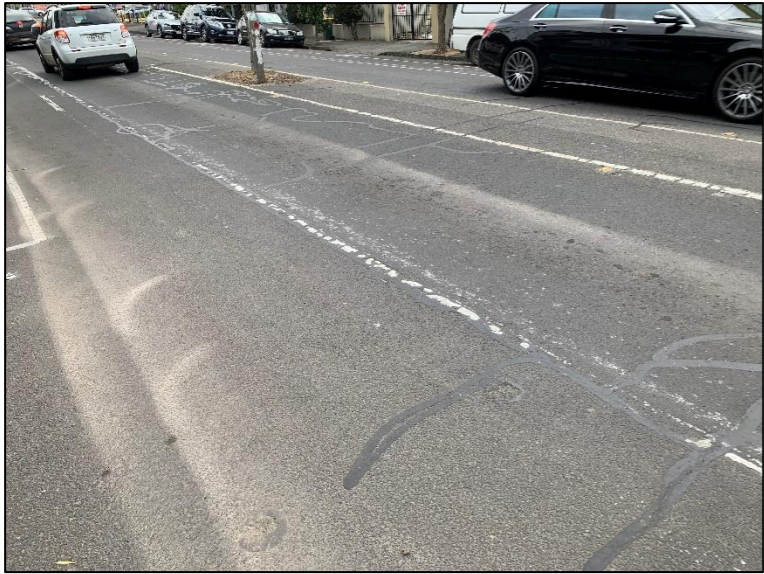
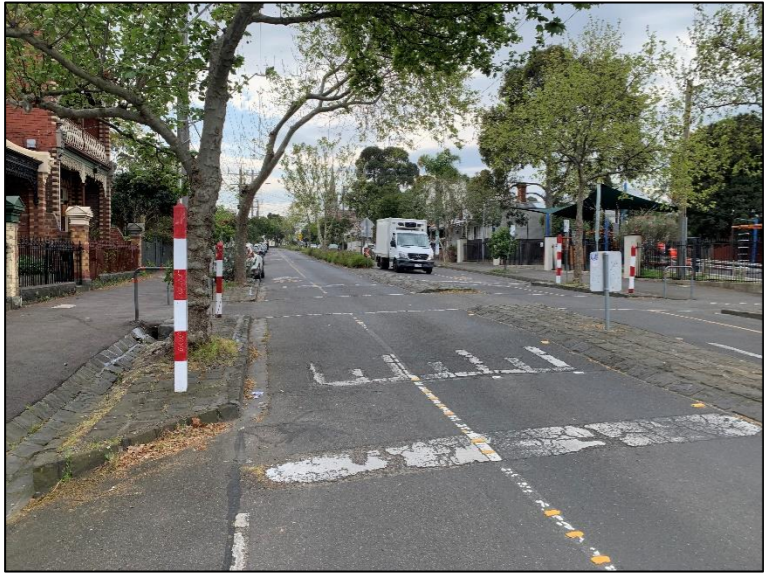
| Audit Findings | Risk Assessment | | | Recommendations | | Responsible Officer | |
|---|---|---|---|---|---|---|---|
| <p>7) The auditors note significant pavement marking / linemarking fading along the length of Wellington St for bicycle infrastructure (bicycle lanes, bicycle hold boxes, etc.), parking limits, and at raised pavement and road hump locations. Pavement markings aid both motorists and cyclists in delineating road space and maintain separation between the different road users. Furthermore, it assists in highlighting oncoming road infrastructure or hazards. Faded pavement markings increase the risk for cyclist-vehicle crash types, such as side-swipe or clipping crashes, as vehicles may encroach into the bicycle lanes.</p> | Rare | Serious | <p>MEDIUM</p> <p>(FSI)</p> <p>Safe System energy exceeds tolerable levels</p> | Consider re-painting the faded pavement markings to reinstate visibility and reinforce delineation. (S) | | | |

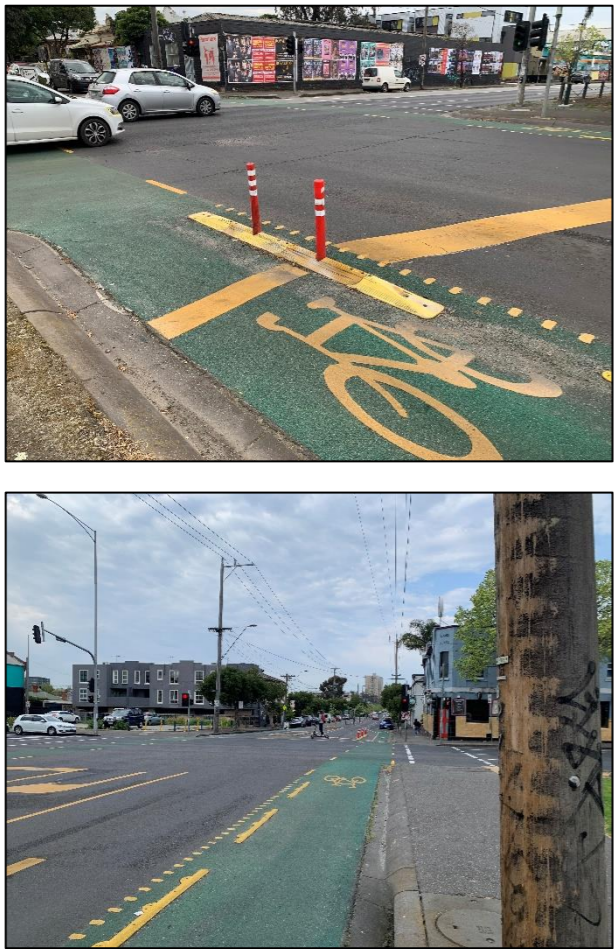
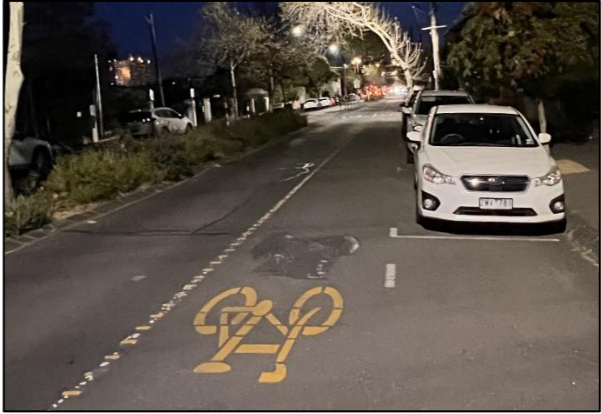
| Audit Findings | Risk Assessment | | | Recommendations | | Responsible Officer | |
|---|---|---|---|---|---|---|---|
| <p>8) The bicycle infrastructure on Wellington Street forms part of Victoria’s Principal Bike Network (PBN), and Queens Parade is part of the Strategic Cycling Corridor (SCC). These classifications identify the routes as crucial for cycling. During the inspection auditors noted that there are significant portions of the bicycle infrastructure that is delineated with yellow line marking, indicating that these treatments are part of a trial or temporary treatment.</p> | N/A | N/A | TO NOTE | <p>Consider removing yellow line marking and installing consistent treatments throughout project limits. (S)</p> <p>Consider carrying out mill and overlay works to remove conflicting line marking and improve clarity of delineation. (S)</p> | | | |

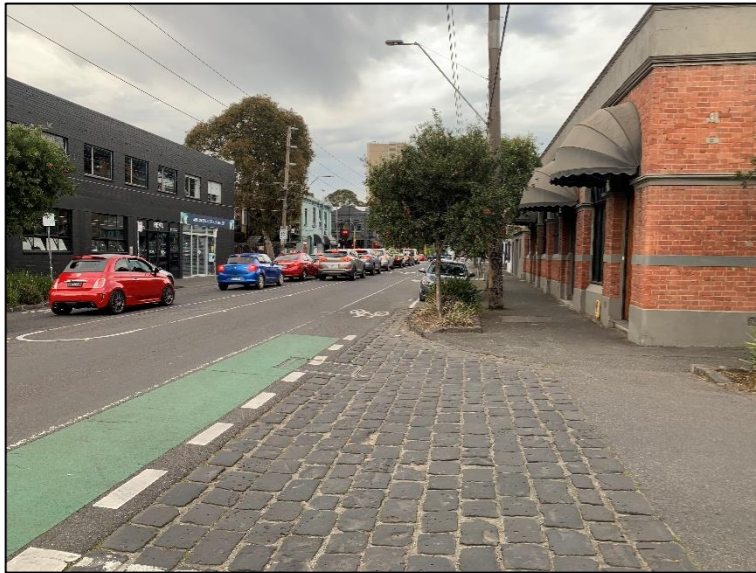
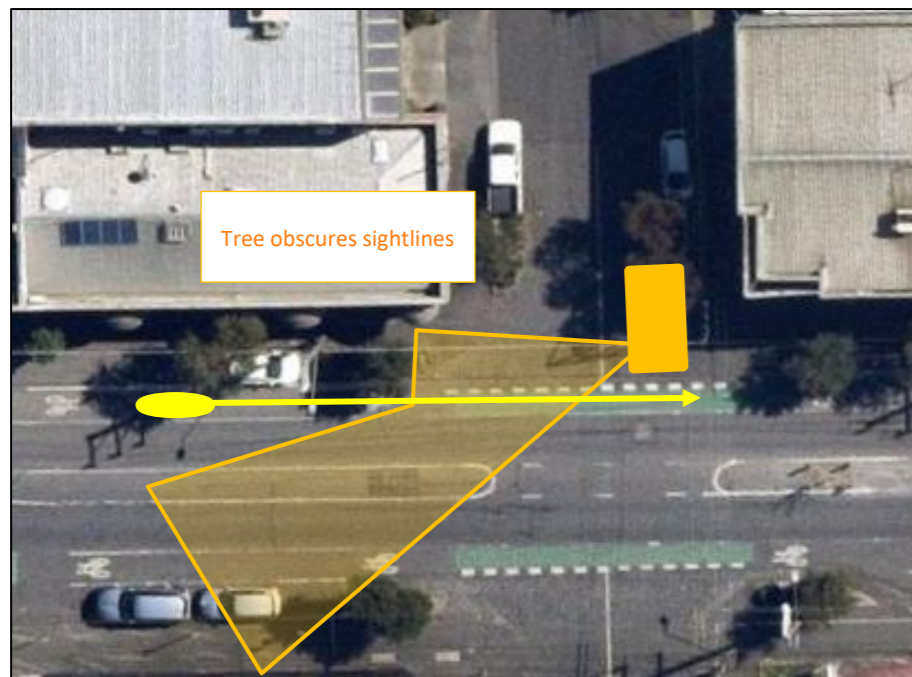
SB sightlines at Sackville Street

9) Auditors note that vehicles turning onto Wellington Street from its side roads typically have obscured sightlines of oncoming traffic due to parked cars and vegetation. Auditors are concerned that motorists will hold their vehicle in the bicycle lane and may proceed through the intersection to have a clear view of any oncoming traffic, increasing the likelihood of bicycle-vehicle and vehicle-vehicle crash types. This issue is present at many side road intersections with Wellington Street.

Rare

Serious

MEDIUM
(FSI)

Safe System
energy
exceeds
tolerable
levels

Consider pruning overgrown vegetation and banning parking close to the side road intersections (with NO PARKING signage), per AS1742.11, to open sightlines. (S)

Consider conducting sight line checks at all side streets to identify and prioritise high-risk sites. (S)

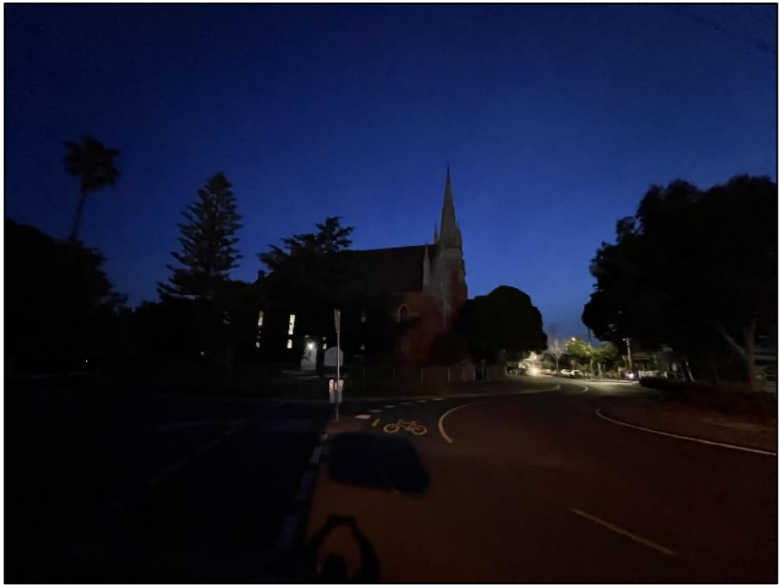
| Audit Findings | Risk Assessment | | | Recommendations | | Responsible Officer | |
|--|---|---|---|---|---|---|---|
| <p>10) Auditors noted significant lighting issues at the west bound Hodgkinson Street approach to the Wellington Street Hodgkinson Street roundabout. This lack of lighting reduces visibility of cyclists moving through the roundabout as well as road hazards such as the splitter island and kerb outstands at the approach. This also reduces drivers ability to see pedestrians crossing at this location when approaching or existing the roundabout. This increases the risk of vehicles cyclist and vehicle pedestrian crash types.</p> | Rare | Serious | <p>MEDIUM</p> <p>(FSI)</p> <p>Safe System energy exceeds tolerable levels</p> | <p>Consider installing lighting at this approach in accordance with AS1158. (S)</p> <p>Consider conducting street lighting assessments along the route. (S)</p> | | | |

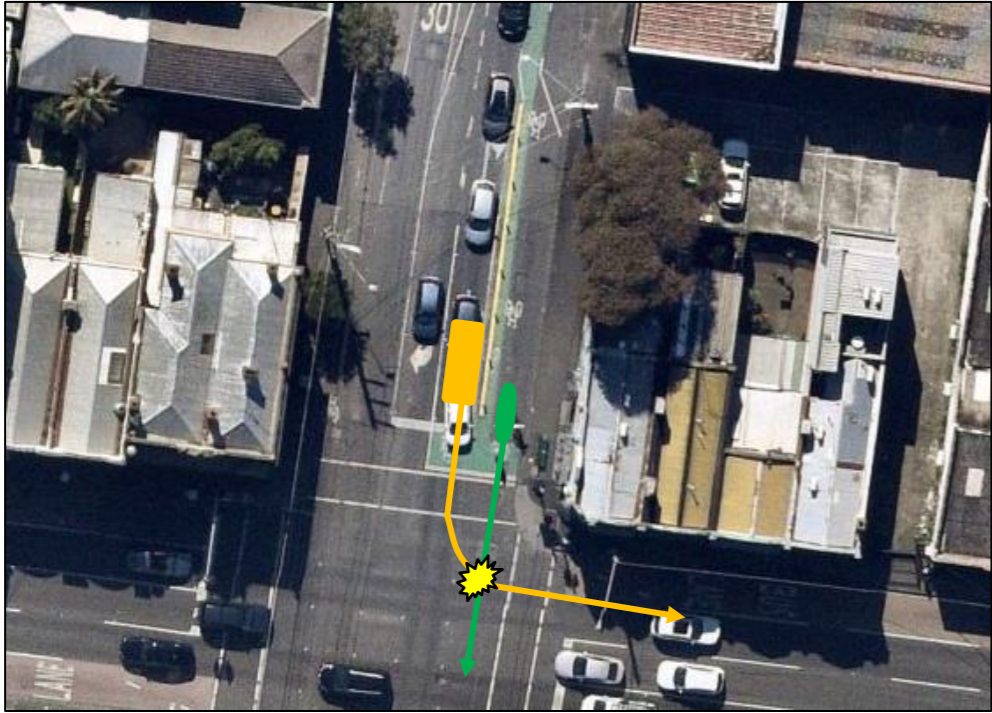
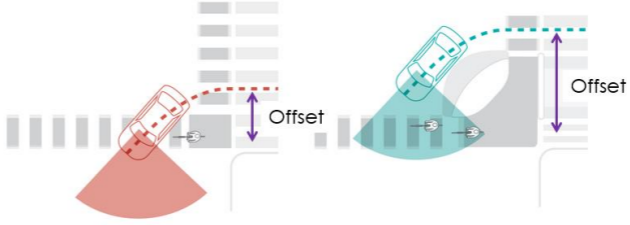
| Audit Findings | Risk Assessment | | | Recommendations | | Responsible Officer | |
|---|---|---|--|--|---|---|---|
| <p>11) Auditors note that at the Wellington Street and Johnston Street intersection, left-turning vehicles onto Johnston Street are required to cross the bicycle lane. Auditors are concerned that the layout of this intersection increases the likelihood of vehicle-cyclist crash types, and this risk is increased during free-flow and peak hours as well as night-time where visibility of the bicycle lane will be poor. Given the expected low speed of turning vehicles, impact speeds are likely to be below the Safe System tolerance for this crash type (30km/h).</p> | Possible | Moderate | <p>HIGH (FSI)</p> <p>Safe System energy within tolerable levels</p> | <p>Consider reconfiguring the intersection to provide greater offset from the bicycle lane to the left-turn traffic lane. This would likely involve removing the right-turn lane. Increasing the offset will improve sight lines between left-turning motorists and through cyclists. (S)</p> <p>Adapted from, “NACTO Don’t Give Up at the Intersection” – red sight lines on the left show a traditional intersection, and green sight lines on the right show an increased offset.</p> <p>This risk is also applicable at the Queens Parade intersection.</p> | | | |
